Structure Number: 18
Original Use: Housekeeping Quarters
Present Use: Personnel Quarters
Construction Date: 1916
Architect: Unknown
Number of Levels: Four (including basement and storage attic)
Total Area: 7,370 square feet
Plan Shape: Rectangular
Basic Construction: Wood framing
Uses per Floor: Basement

-NHL Nomination, Northwestern Branch, National Home for Disabled Volunteer Soldiers (2010)

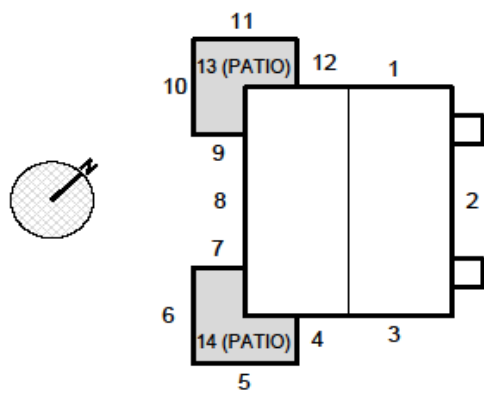
MODERATE REPAIRS ARE NEEDED FOR ALL THE FOUNDATION WALLS AS MINOR CRACKING TO THE EXISTING CONCRETE FOUNDATION WALLS HAS TAKEN PLACE. THIS IS TYPICAL OF ALL THE CONCRETE BUILDING FOUNDATION WALLS AS WELL AS THE PATIO FOUNDATION WALLS.

MINOR REPAIRS ARE NEEDED FOR ALL EXTERIOR WOOD STAIRS & ASSOCIATED PATIOS. MINOR DETERIORATION OF THE EXPOSED WOOD HAS TAKEN PLACE OVER TIME. IT IS RECOMMENDED THAT THE EXPOSED PATIO STAIRS BE REFINISHED TO HELP PREVENT FURTHER DETERIORATION.

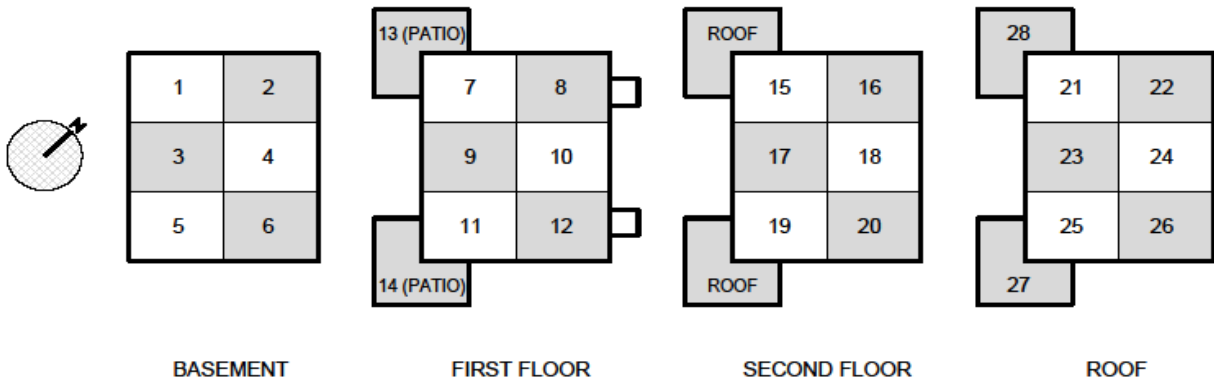
MODERATE REPAIRS ARE NEEDED FOR THE FIRST FLOOR FRAMING AND ASSOCIATED FLOOR BOARDS. MINOR DETERIORATION OF THE EXISTING FIRST FLOOR FRAMING & ASSOCIATED FLOOR BOARDS WAS FOUND AS NOTED BELOW. HOWEVER, THE FOLLOWING TWO ITEMS ARE OF MORE SIGNIFICANT CONCERN AND SHOULD BE ADDRESSED IN THE NEAR FUTURE. FIRST, THERE WAS SIGNIFICANT SPLITTING OF THE EXISTING FIRST FLOOR WOOD SUPPORT BEAMS. IN ADDITION, A SIGNIFICANT 'SAG' & STRUCTURAL DEFLECTION WAS NOTED IN THE AREA OF THE SECOND FLOOR 'SLEEPING' PORCHES. IN BOTH OF THESE INSTANCES, THESE ITEMS SHOULD BE ADDRESSED IN THE NEAR FUTURE TO PREVENT FURTHER STRUCTURAL DETERIORATION.

MODERATE REPAIRS ARE NEEDED FOR ROOF FRAMING AND ASSOCIATED ROOF BOARDS. MINOR DETERIORATION OF THE EXISTING ROOF FRAMING & ASSOCIATED FLOOR BOARDS WAS FOUND AS NOTED BELOW.
